Church of Our Lady, Star Of The Sea, Ilfracombe, 2011

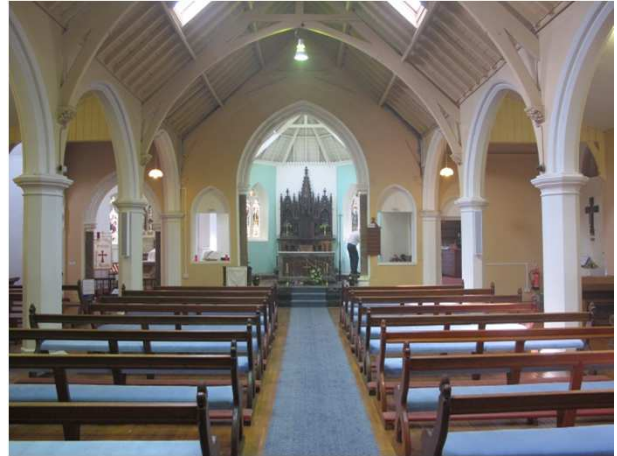
Interior of the church before reordering. Existing floor constructed from concrete slab. Slab was too poor to save so new one was cast.

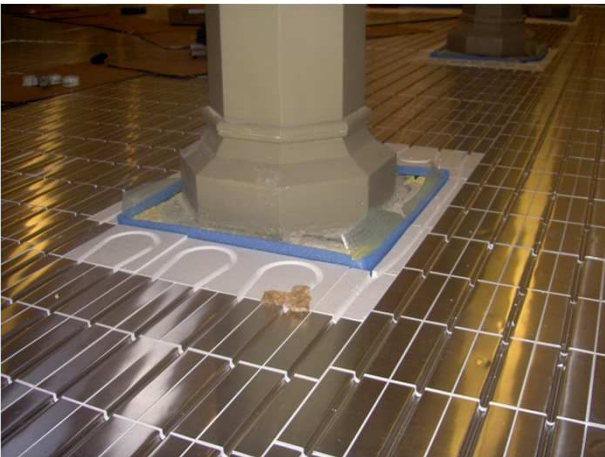
JUPITER IDEAL system (125mm pipe centres) installed throughout.

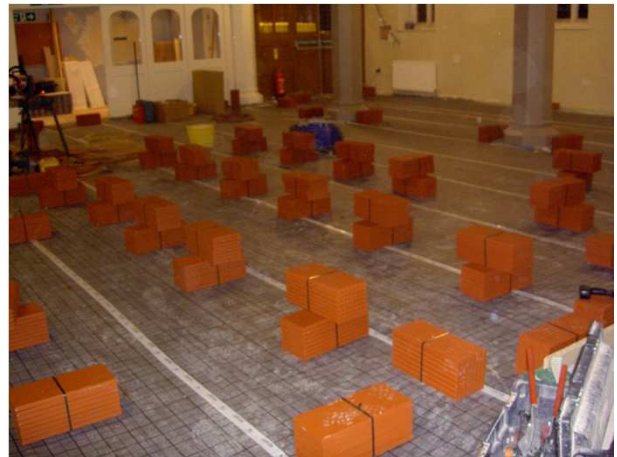
Screed Replacement Tiles are laid out in piles prior to installation.

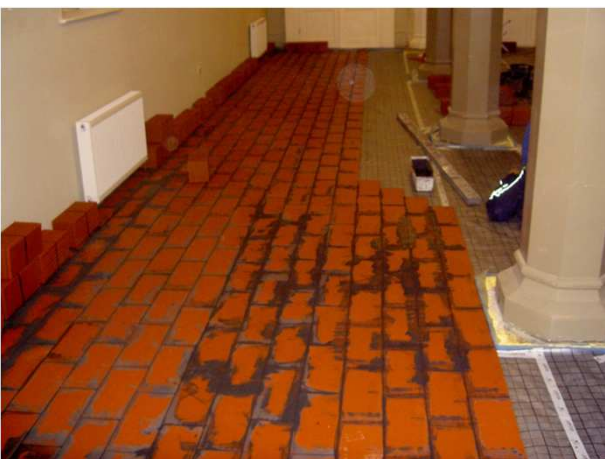
Screed Replacement Tiles installed in brick bond format .

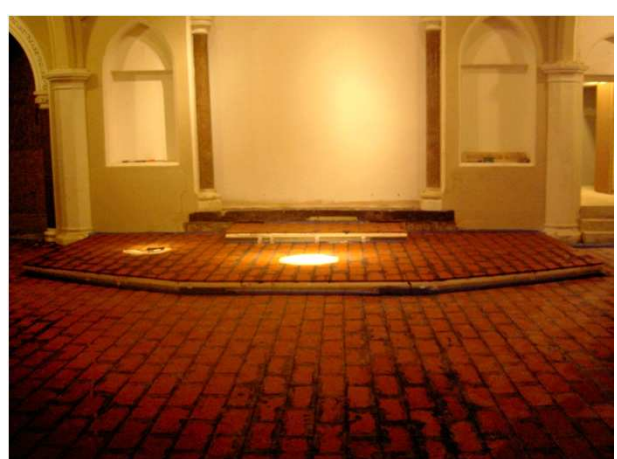
Screed Replacement Tiles installed in preparation for carpet and natural slate finish.
